NUMBER: 08-001-19 REV. B

GROUP: 08 - Electrical

UAQ Radio Enhancements

2018 (JL) Jeep Wrangler

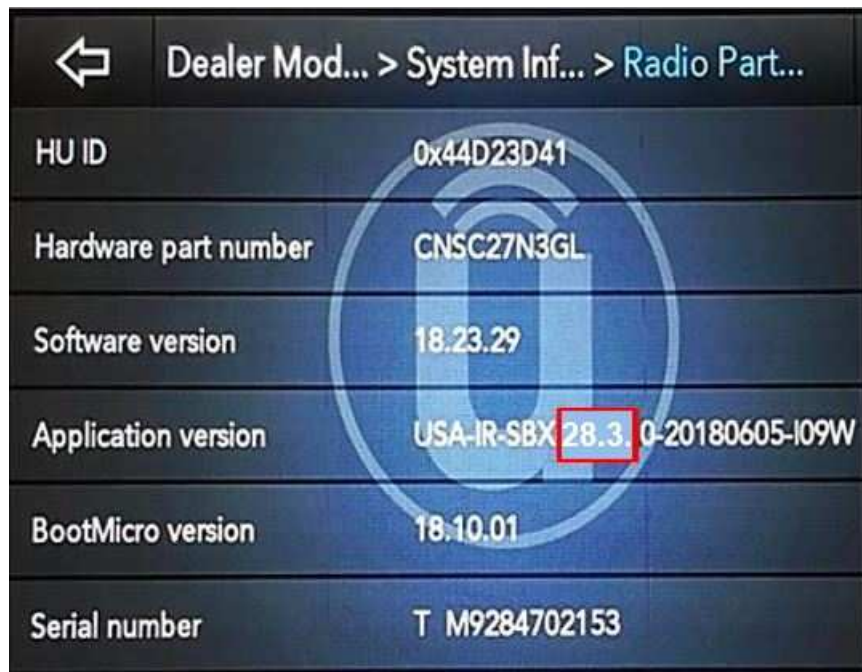
Fig. 1

1. Verify the radio software version. Radio must be in Dealer Mode to verify by following these steps:
 - a. Push and hold the front defrost, driver temperature up and temperature down buttons simultaneously until the 'Dealer Mode' screen appears (approximately seven seconds). Release buttons.
 - b. Select "Radio Part Information". The software version will be listed next to "Application Version" (Fig. 1) .

Radio Software Level Screen

2. Is the radio software level (Application Version) at or higher than 28.3?
 - YES >>> The radio software is already up to date. Normal diagnosis should be performed.
 - NO >>> Proceed to [Step 1](#) of the Repair Procedure.

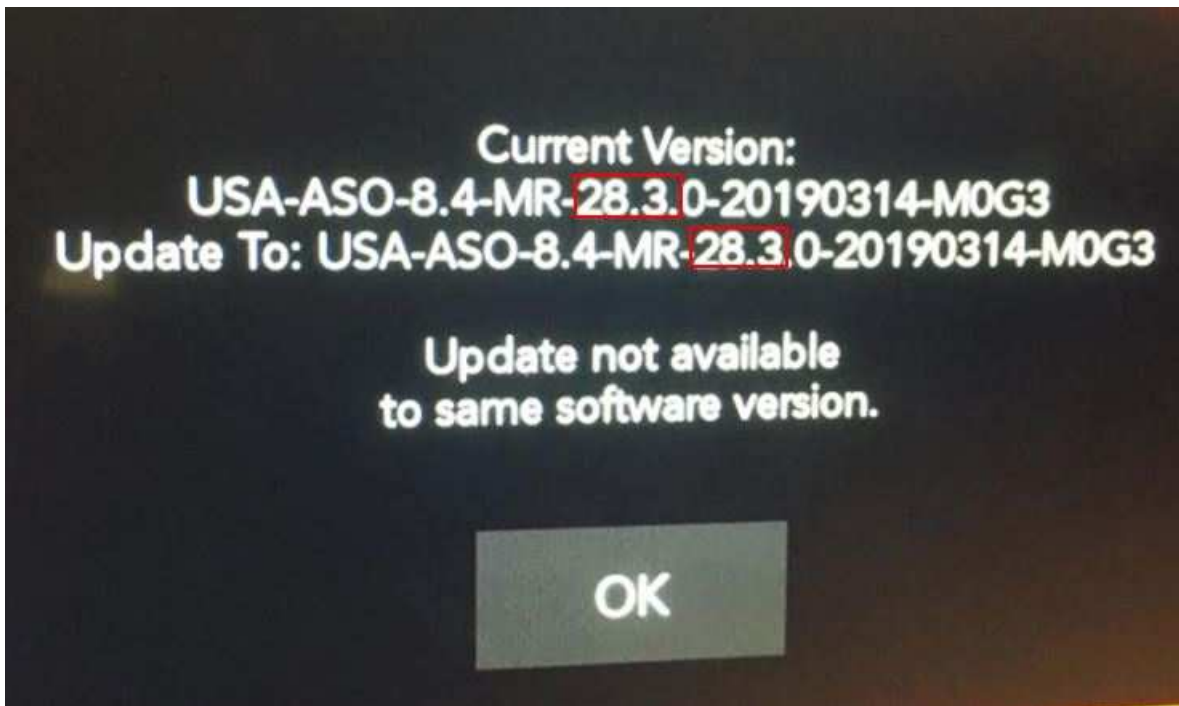
Fig. 10
Radio Software Updated

15. After the update has completed, the radio will shut down. With the USB flash drive still inserted in the USB port, turn the ignition back to the run position. If the radio has been updated correctly, the screen in (Fig. 10) will be displayed. Press "OK" and remove the USB flash drive.
